Chandra Flight Note

FLIGHT NOTE NO.	441
SUBJECT	HRC -Y Shutter Failure (OCCcm06110): FDB Closeout
DATE	22 October 2004
AUTHOR	Michael Juda for the HRC Team

1 Summary

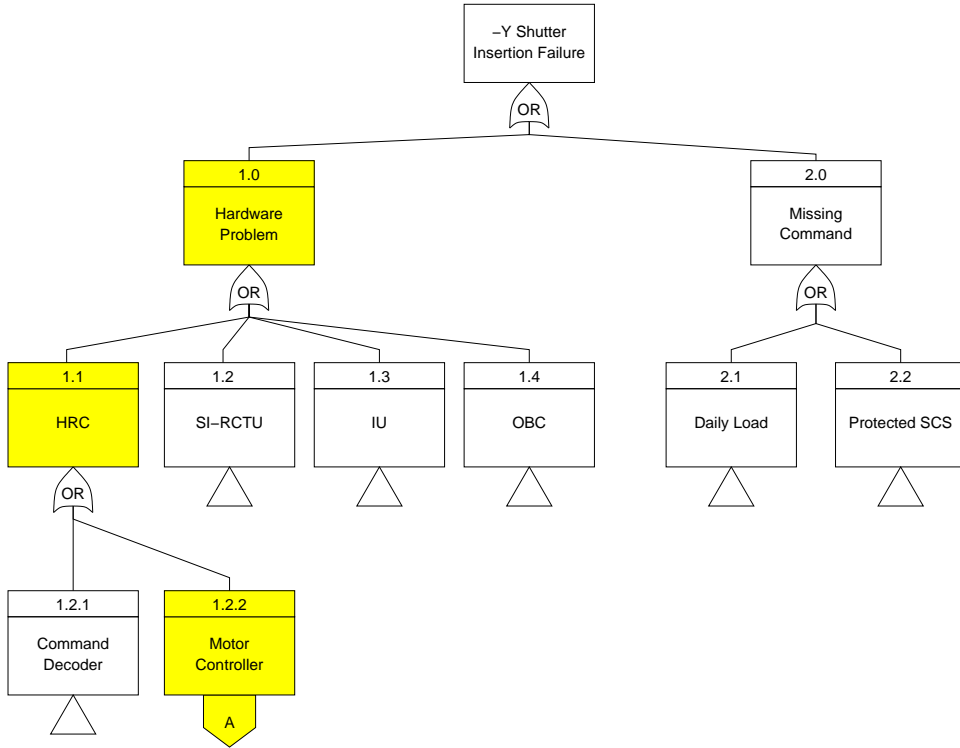
The SEP2203B command loads contained the necessary commands for the HRC shutter insertion; so, an on-board hardware problem was the immediately identified reason for the anomaly. Figure 1 shows the top-level fault-tree for the shutter insertion failure; while figure 2 shows the HRC motor controller branch where, as we describe below, the fault occurred.

Figure 1: Top-level fault-tree for the HRC -Y shutter insertion failure

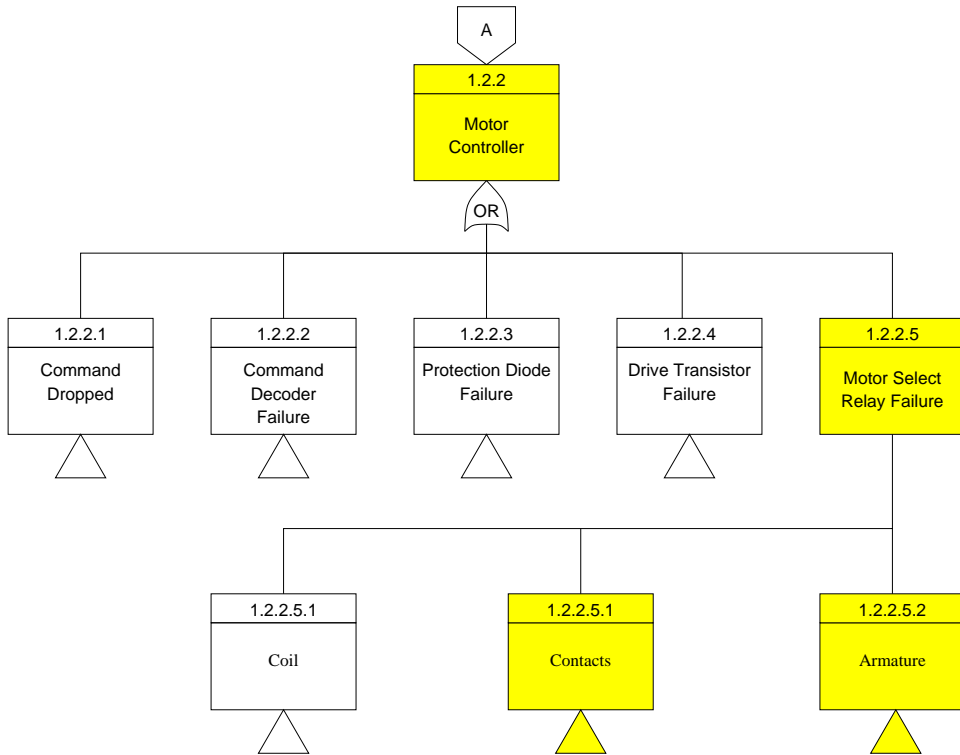
Figure 2: HRC motor controller branch of the fault-tree for the HRC -Y shutter insertion failure

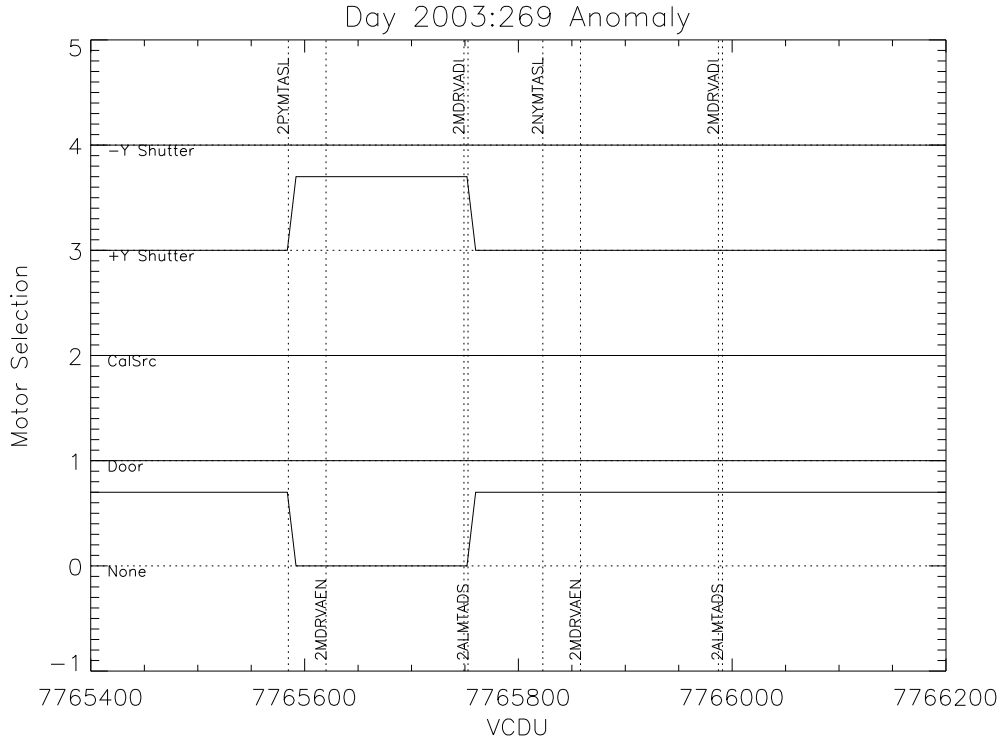
Figure 3: Motor selection bit telemetry during the shutter insert commanding on day 2003:269. The vertical text and dashed lines are the HRC command mnemonics and scheduled times.

to the the command to select the -Y shutter but that the shutter did not move from the home limit switch because the motor itself did not get selected by the controller. A similar telemetry response was apparent during the day 2003:271 shutter retraction interval. This isolates the fault to within a small portion of the motor controller circuit.

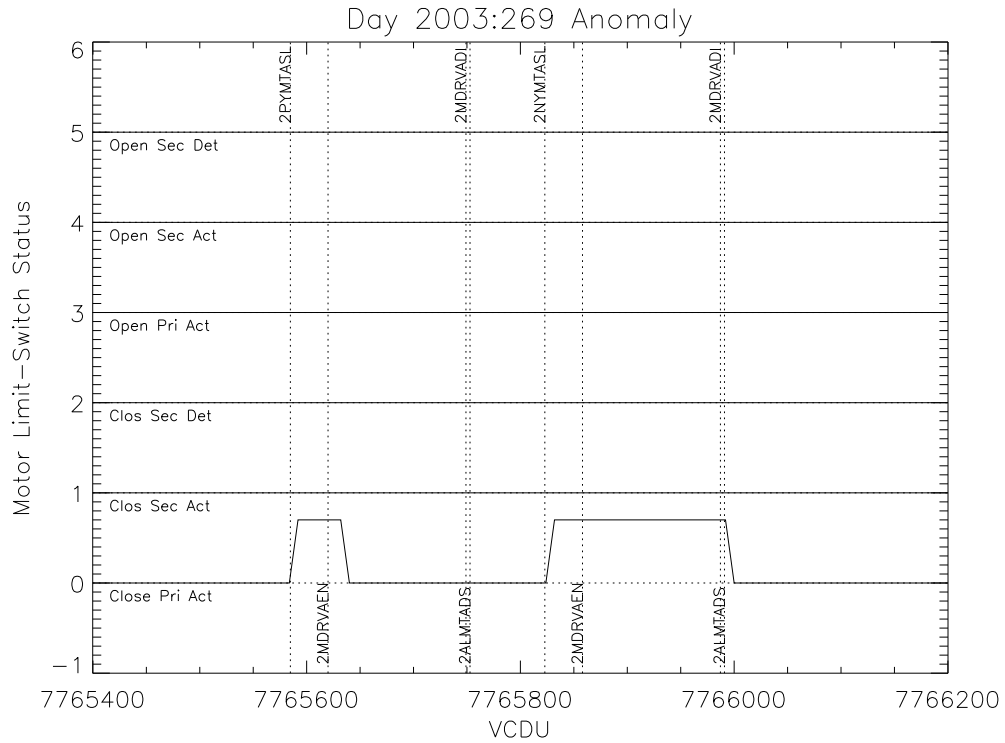
Figure 4: Motor limit switch bit telemetry during the shutter insert commanding on day 2003:269. The vertical text and dashed lines are the HRC command mnemonics and scheduled times.

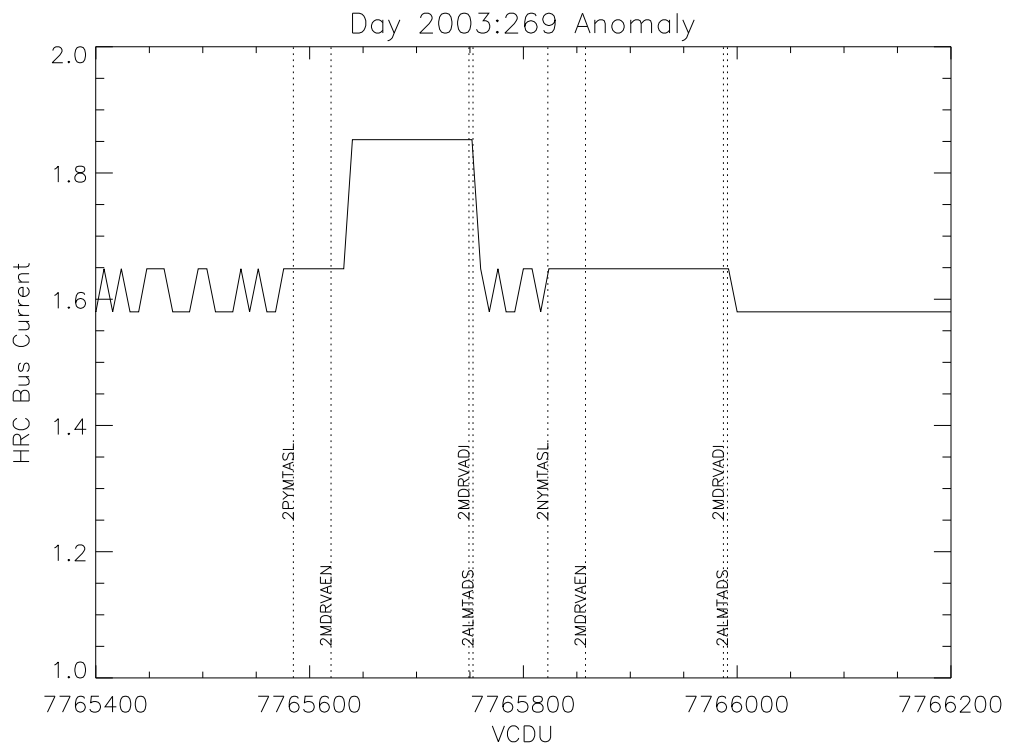
Figure 5: HRC bus current telemetry during the shutter insert commanding on day 2003:269. The vertical text and dashed lines are the HRC command mnemonics and scheduled times.

The slight increase in bus current when the motor is selected is an indication that the coil was energized which eliminates all but the first two of these as the cause of the anomaly.

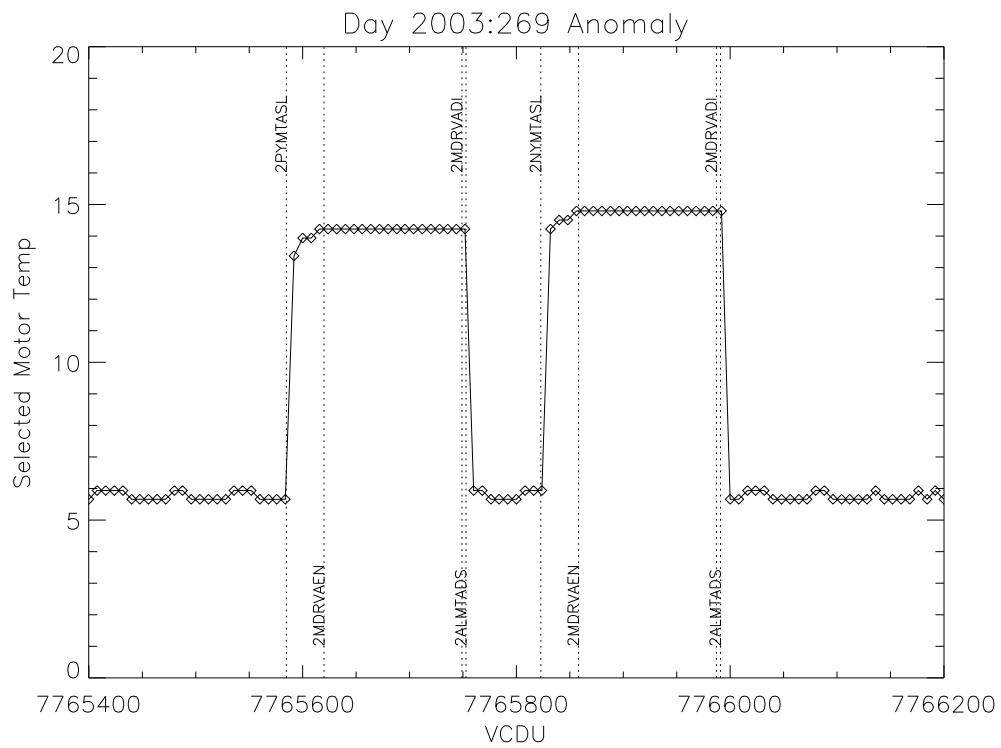
Figure 6: Selected motor temperature telemetry during the shutter insert commanding on day 2003:269. The vertical text and dashed lines are the HRC command mnemonics and scheduled times.

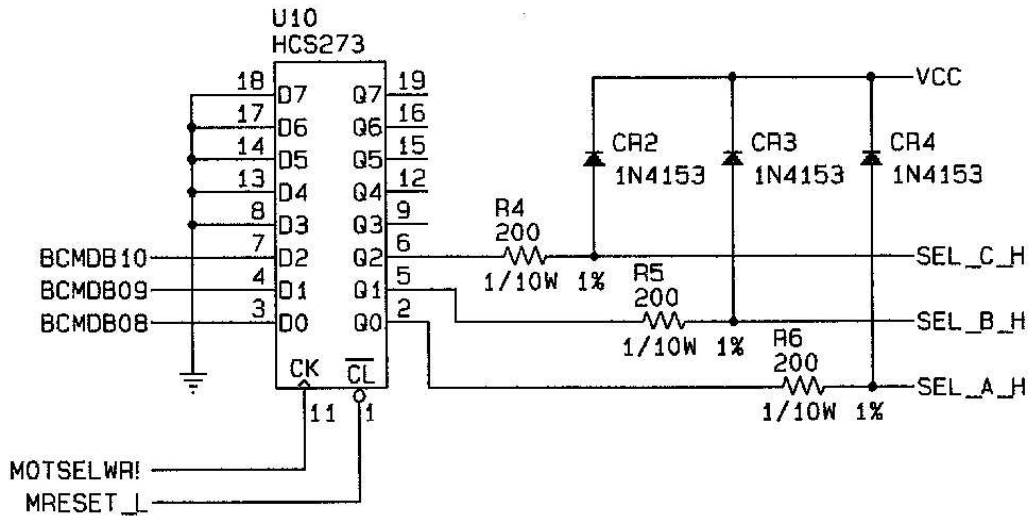
Figure 7: Buffer circuit for serial-digital command bits of the selected motor from motor controller schematic HRC-5222.

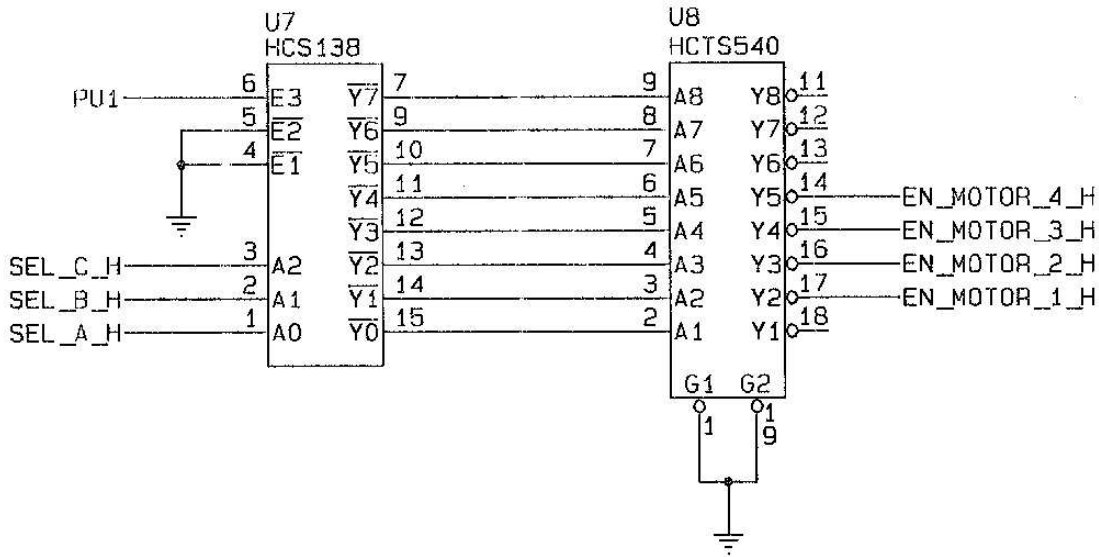
and BCMDB10) into internal signal bits (SEL_A_H, SEL_B_H, and SEL_C_H) that hold the selected motor information. These internal signals are used to select the portions of the motor control electronics associated with the selected mechanism. The bit SEL_C_H is only set when the -Y shutter is selected; the fact that the thermistor and limit switches associated with the -Y shutter were selected demonstrates that the serial-digital command is being processed correctly. Figure 8 is a portion of the motor select schematic that shows how these signals are used to generate the four motor select signals. The signal EN_MOTOR_4_H is used to select the -Y shutter motor and is not used anywhere else. Figure 9 is a portion of the motor select schematic which shows where this signal is used to switch the transistor that energizes the relay-coil to select the motor; identical circuits are used for the other three motors. The signal MOTOR_4_ON_H in figure 9 provides the telemetry indicator that the motor has been selected. Since the telemetry indicated that the -Y shutter selection bit did not change when the motor was selected and the motor did not turn when the motor drive was enabled then at least two of the relay contacts did not close. This outcome could have resulted from:

Figure 8: Schematic of the motor select command bits decoder

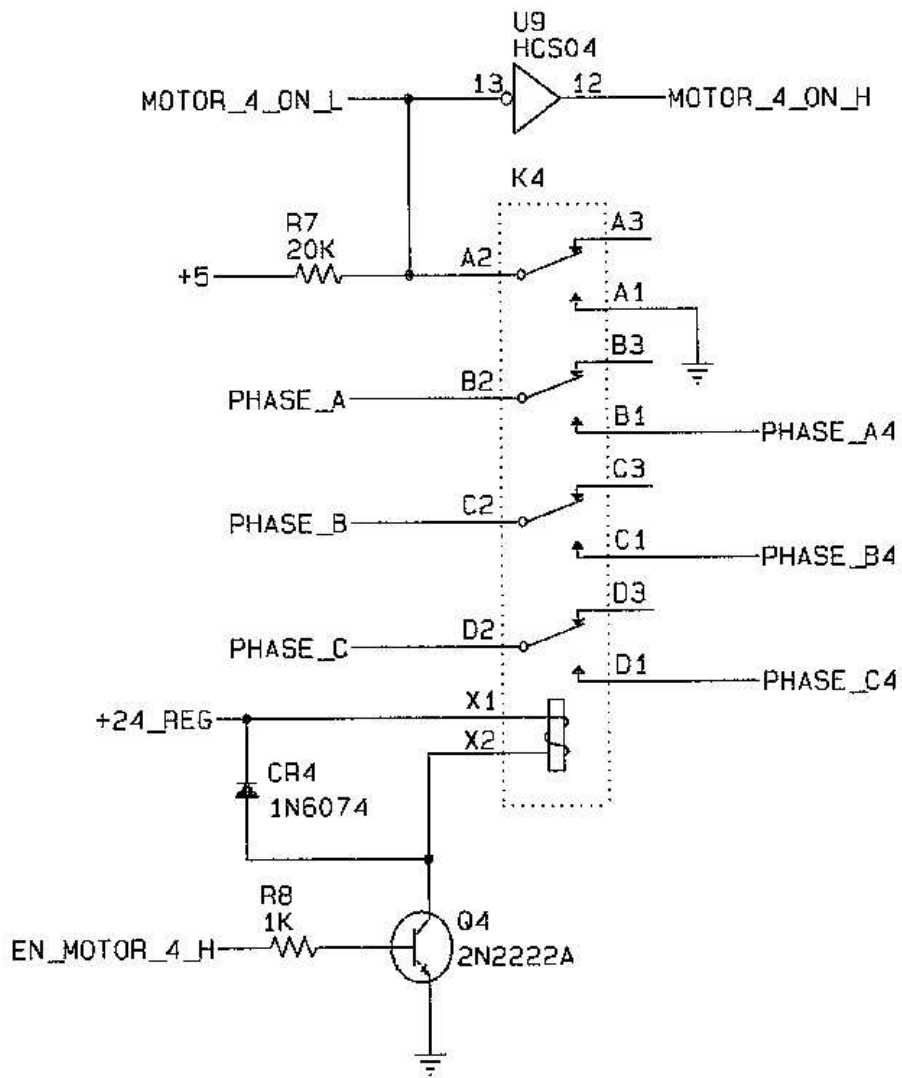
- damage to the contacts in the relay
- damage to the relay armature
- damage to the relay coil
- failure of the drive transistor
- failure in the protection diode
- the signal EN_MOTOR_4_H is missing

Figure 9: Schematic of the motor select relay and drive circuit.

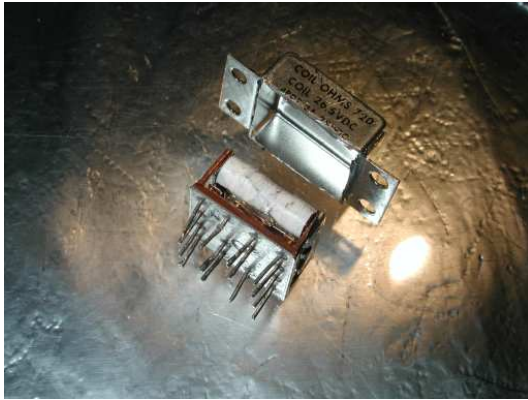
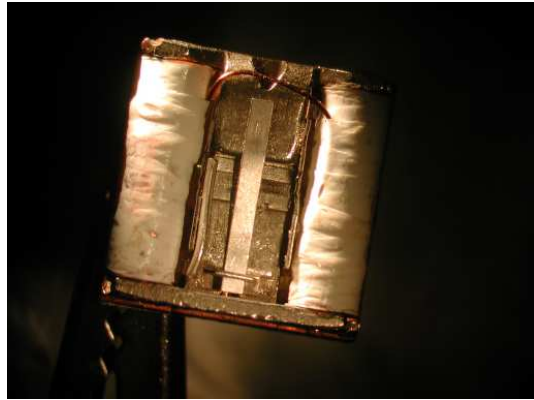
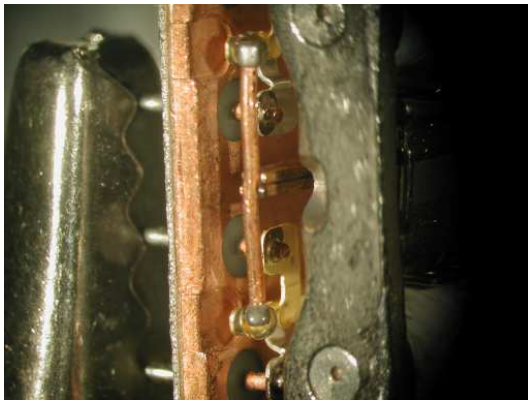
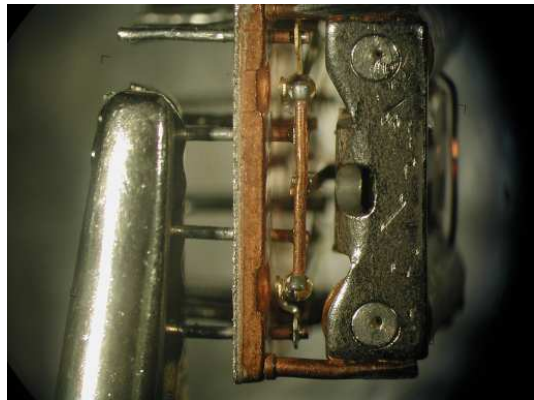
Figure A-1: Relay Views

Two relays, #2 and 4, were exposed to nitric acid (5%) fumes after initial switching tests in a quiescent condition for 24 hours. The switching test at 24 hours showed normal operation, with the appearance of thin oxide layers. The relays were then subjected to nitric acid fumes for 150 hours. At the end of the 150 hours relays were found to be heavily oxidized — worst case situation in long-term quiescent storage. The oxide layers are shown in the attached photographs.

This strongly suggested the growth of oxides on copper elements of the contact assembly over a long period of exposure to oxidizing environment and the oxidation as the primary source of particles in the relay.

The failure analysis concluded that the relay failure in orbit was likely caused by particles; the particles being generated as a result of oxidation of the copper elements of the contact assembly during long term storage (4 years) in oxidizing environment. This failure mechanism suggests that all the HRC motor select relays on- orbit have the potential to fail in a similar fashion.

The HRC door mechanism should not be exercised. The door requires the its motor select relay to operate properly to both close and open the door. The door does not have any failsafe features in the mechanism in the event that the door was closed and the motor select relay failed at that time. This would leave the HRC door permanently closed and render the HRC useless for the remainder of the mission.
