## ACIS Door Failure Investigation: Technical Details and Mitigation Procedures

Mark A. Kahan \*, Neil L. Tice \*\*, William A. Podgorski \*\*\*, Paul P. Plucinsky \*\*\*, & Keith B. Doyle \*

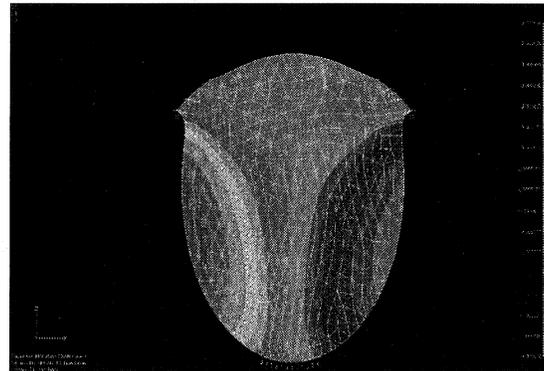
Relative O-Ring X - Disp;  $\Delta T = -80\text{ }^\circ\text{C}$

Combo of Effects May Break Stiction  
Pit Size:  $\sim 10\text{ }\mu\text{m}$  wide;  $\sim 2\text{ }\mu\text{m}$  deep  
 $8\text{ }\mu\text{m}$  Z-Disp due to Soak is  $> 2\text{ }\mu\text{m}$   
 $35\text{ }\mu\text{m}$  X-Disp due to Gradient is  $> 10\text{ }\mu\text{m}$

**Figure 4. AXAF Door: O-ring Motions**

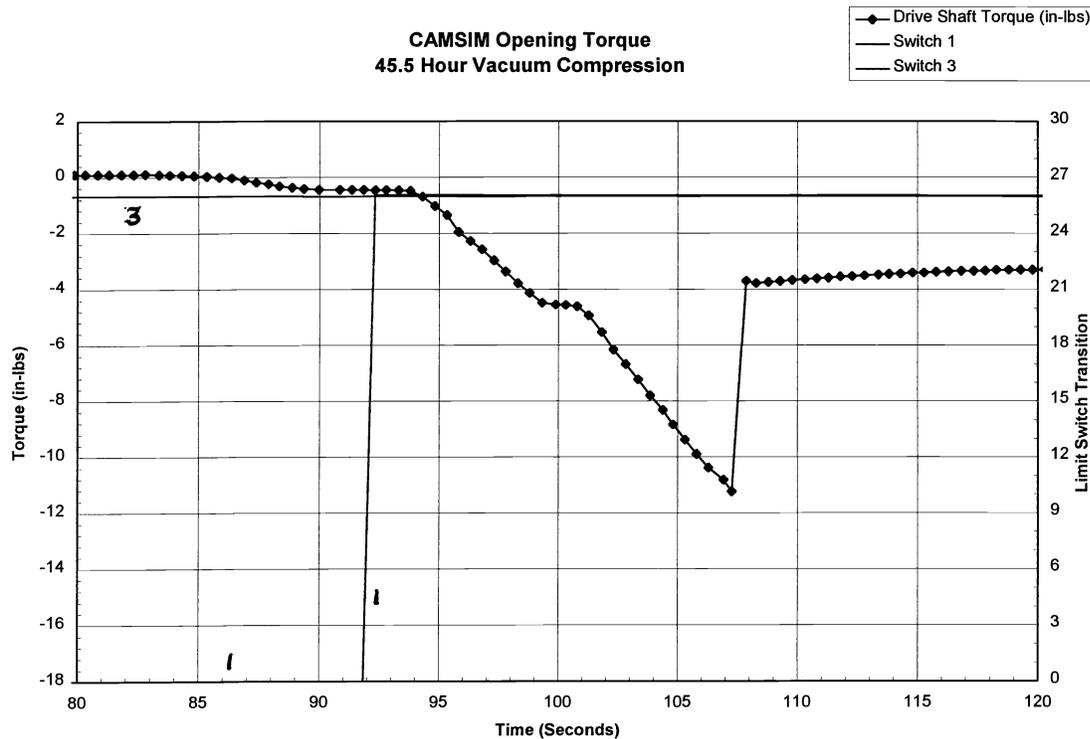
**Figure 5. Typical Torque Curve for Opening ACIS Door**

Figure 5 shows a typical torque curve. The strain gauge amplifiers were zeroed prior to opening even though this measurement contains significant zero offset. This offset is caused by the strain in the shaft required to maintain the 50 pound preload on the closed door. When the actuator unlatches (at ~85 seconds in Fig 5) the forces from the preload back-drive the actuator until the running torque of the actuator arrests this motion. This exhibits itself as a level portion of the curve where the linear wax actuator "catches up" to the back-driven output shaft. During this time the limit switch picks up showing that the actuator is unlatched. As the wax actuator continues its stroke what remains of the 50 pound preload is removed as shown in Figure 5 by steadily declining torque. Eventually, the preload torque is completely relieved, which removes the compression on the door linkage. At this time the linkage travels through a dead band caused by the clearances in the various mechanical components. This too is exhibited by a second, level segment of the curve (~100 seconds) and represents the true zero torque value at the shaft. As rotation continues, the linkage begins to pull on the door and the shaft torque curve in Figure 5 continues to decline. At this point the linkage is in transition from compression to tension and so represents a change of sign for the shaft torque. From this point on the torque measured is the torque caused by the adhesive forces between the O-ring and the door and any small running torque caused by bearing friction and gravitational loads. As can plainly be seen this continues until the torque curve discontinuously jumps. This discontinuity has been visually correlated with door first motion on all of the tests performed. A small residual strain remains after the discontinuity and is a result of the now freely hanging door with gravity pulling it open and any residual torque in the mechanism.

For the purposes of this analysis the second plateau caused by the unloading of the door mechanism is used as zero. The minimum reached just prior to the discontinuity was used as the opening torque. Thus, in the example shown in Figure 5 the opening torque is about 6.5 in-lbs.

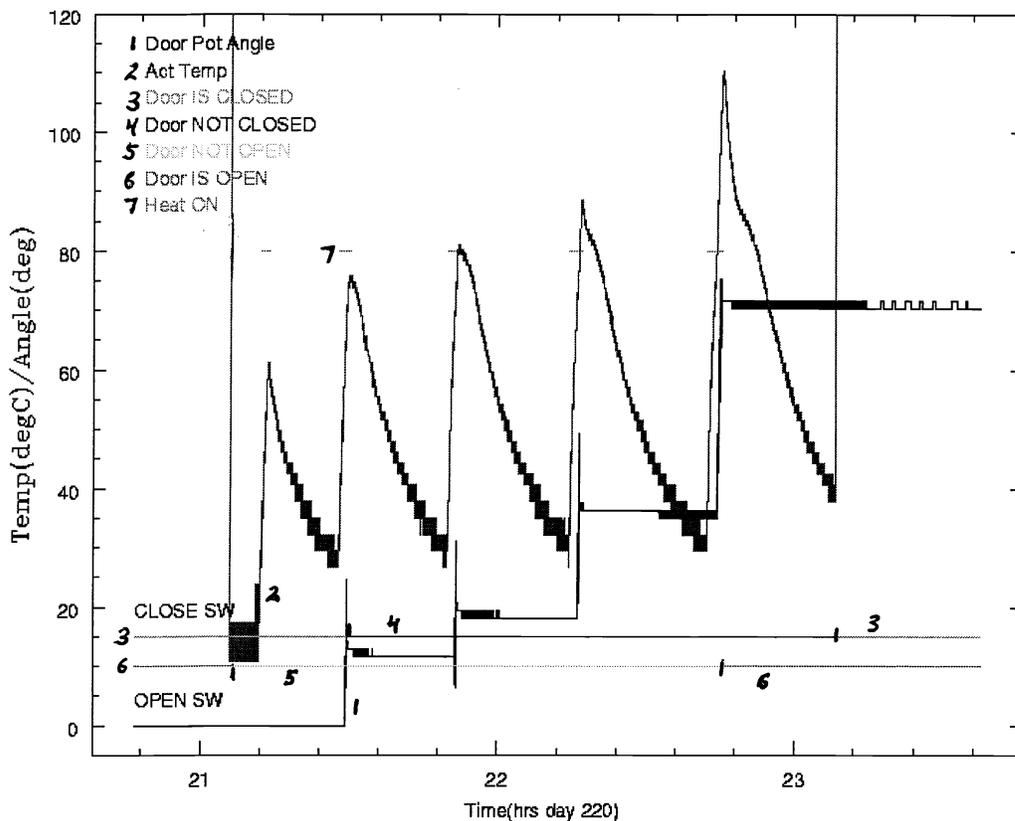
**Figure 6 – On-Orbit ACIS Door Opening**

The Chandra X-ray Observatory was launched from KSC on July 23, 1999 in the orbiter Columbia. On August 8, 1999 the ACIS door was opened as planned, 16 days after launch. The door opening sequence is shown in Figure 6. The same procedure was used to open the door in flight as had been used on the ground test at TRW. The only difference was the timing of the individual heating pulses. The door was opened with 5 heating cycles of 90, 110, 125, 140 and 200 sec. and the actuator reached a maximum temperature of 56.1, 68.9, 79.2, 87.0, and 110.3°C. The spacecraft bus voltage was 31.0 V and the input voltage at the PSMC was 30.4 V. Actuator temperature, door angles and limit switch transitions were all as expected and are shown in the figure. With the successful door opening, the Chandra X-ray Observatory planned calibration observations were completed and scientific studies are now being performed as intended. The stiction mitigation technique we developed was essential to allow us to proceed through launch, but the actual stiction values seen by the Flight Unit were sufficiently low (with the KSC re-setting of our stiction-"clock") that its use was not required.
