## ACIS Door Failure Investigation: Technical Details and Mitigation Procedures

Mark A. Kahan \*, Neil L. Tice \*\*, William A. Podgorski \*\*\*, Paul P. Plucinsky \*\*\*, & Keith B. Doyle \*

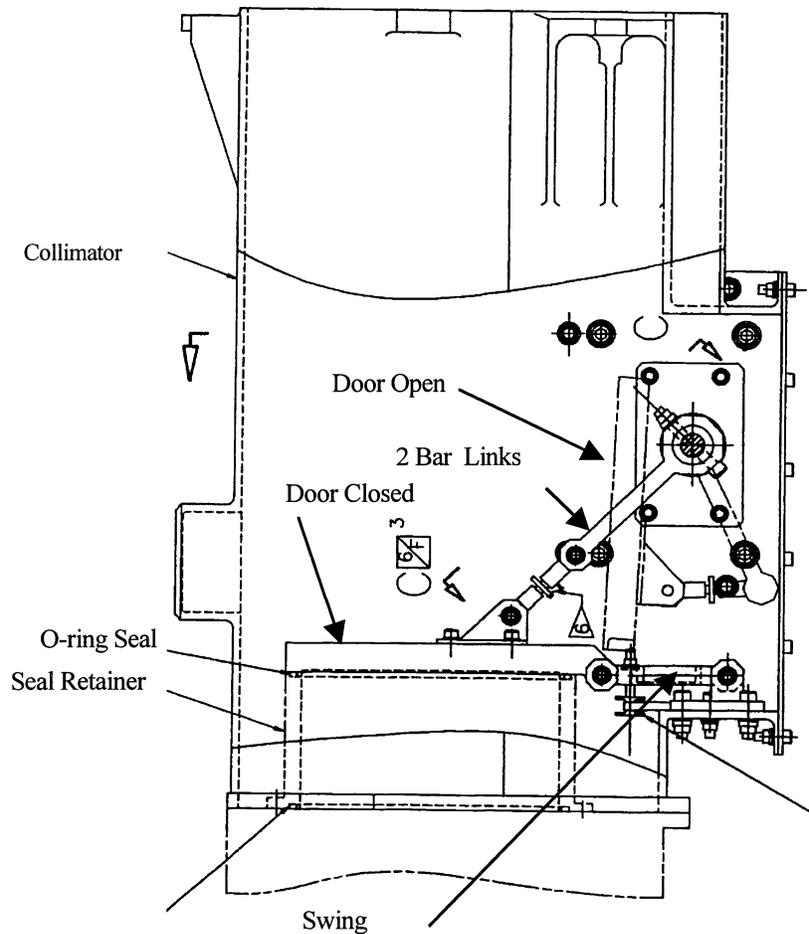
**Figure 2 – ACIS Door Mechanism**

The output torque required from the door actuator was almost entirely driven by the expected stiction that could develop in the O-ring door seal. A cross-section of the mechanism is shown in Figure 2 and shows the open and closed door configurations. The two bar linkage applies around 222 N (50 lbf) of force (1.8 Nm or 16 in-lbs) output torque from the rotary actuator) to the O-ring seal when in the straightened position. This force is required to compress the O-ring sufficiently so that the detector assembly can be evacuated. The mechanism itself consists of the aluminum door, dry Teflon<sup>®</sup> bushings in all rotating joints, titanium/aluminum linkages, a titanium collimator, aluminum seal retainer and the 15-5ph stainless steel linkage driveshaft. The slip-fit Teflon bushings all have redundant moving interfaces which would nominally still allow rotation if one of

the surfaces were to bind. Running torque for the mechanism was very low, even in 1G environments, since the door weighs only about 0.11 kgm (0.25 lbs). The total running torque for the drive train was only around 0.5 Nm (4.5 in-lbs), which was mostly the frictional and spring losses inside the rotary actuator. The frictional losses in the Torlon bushings were minimal. Analysis and testing showed that there was not an issue with clearance changes that could result in any binding of mechanism components, even at the most extreme temperatures. Additionally (post-failure), the mechanical advantages at all joints were re-computed allowing for worst case angular positions (as loose tolerances can sometimes lead to unfavorable piece-part mechanical positions). This analysis showed no positions resulting in abnormal forces or restraints.
